Fort Meade Fire Department

MVC at Annapolis and Camp Meade Rds.

2 March 1974

Accident photographs from the U.S. Army.

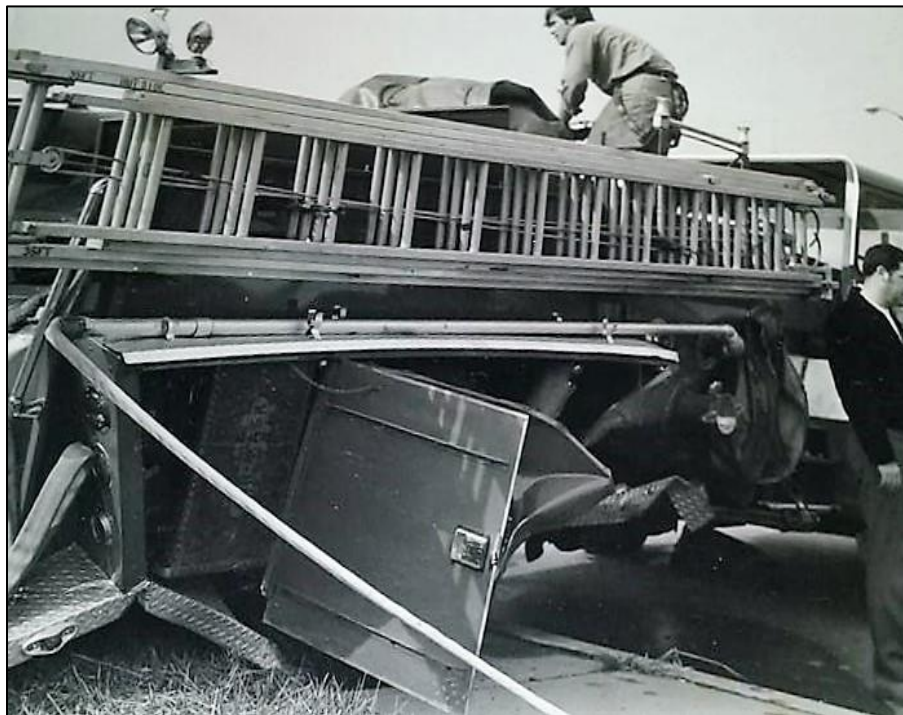
Right side of fire truck where automobile struck the unit.

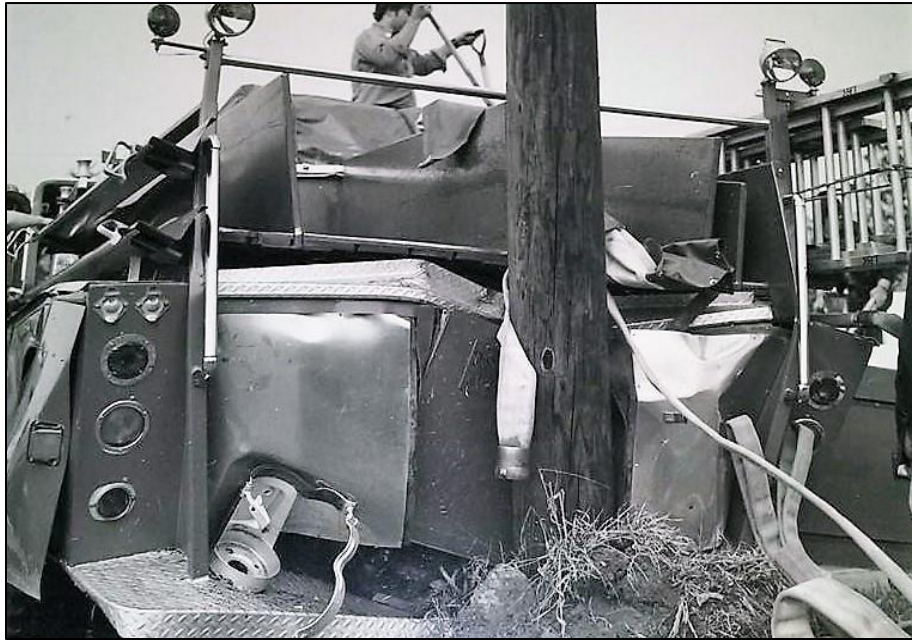
Fire truck spun 360 degrees before striking utility pole after impact with automobile.

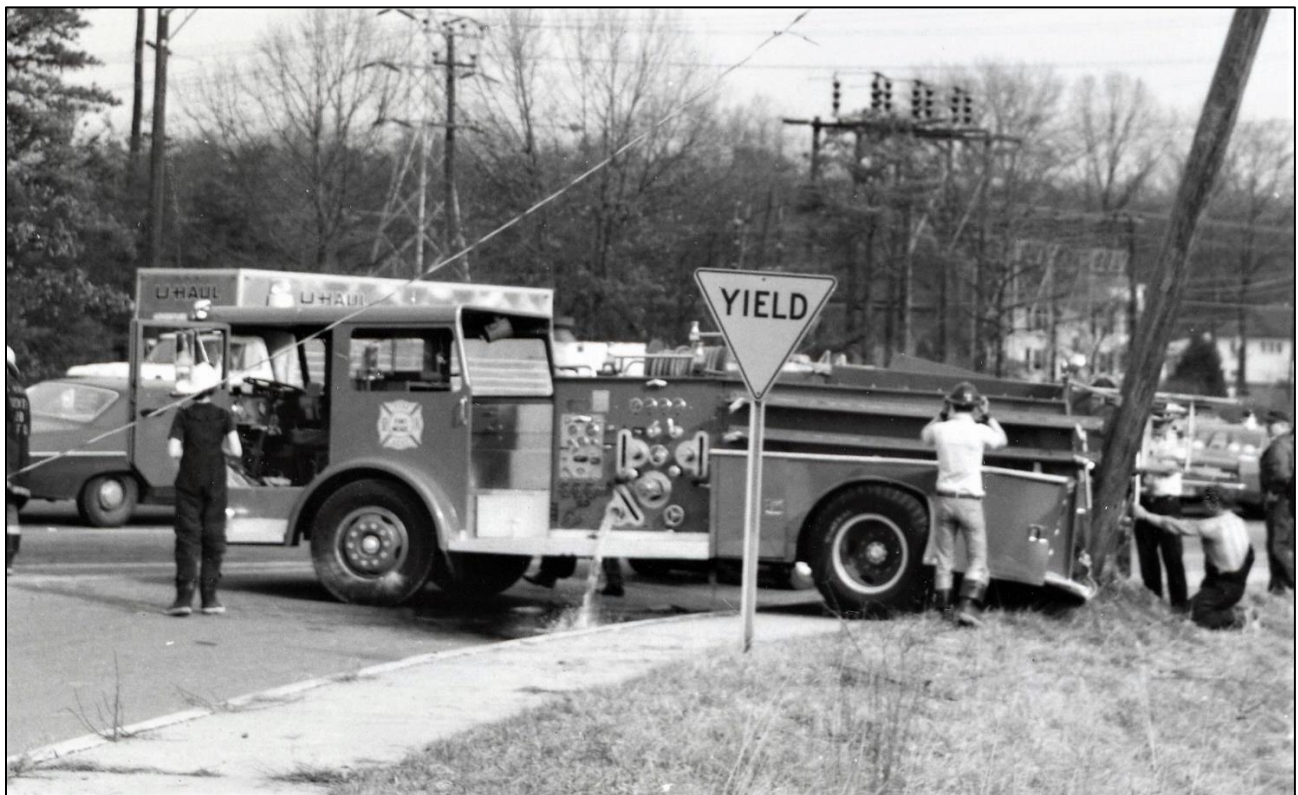
American LaFrance pumper came to rest against the utility pole.

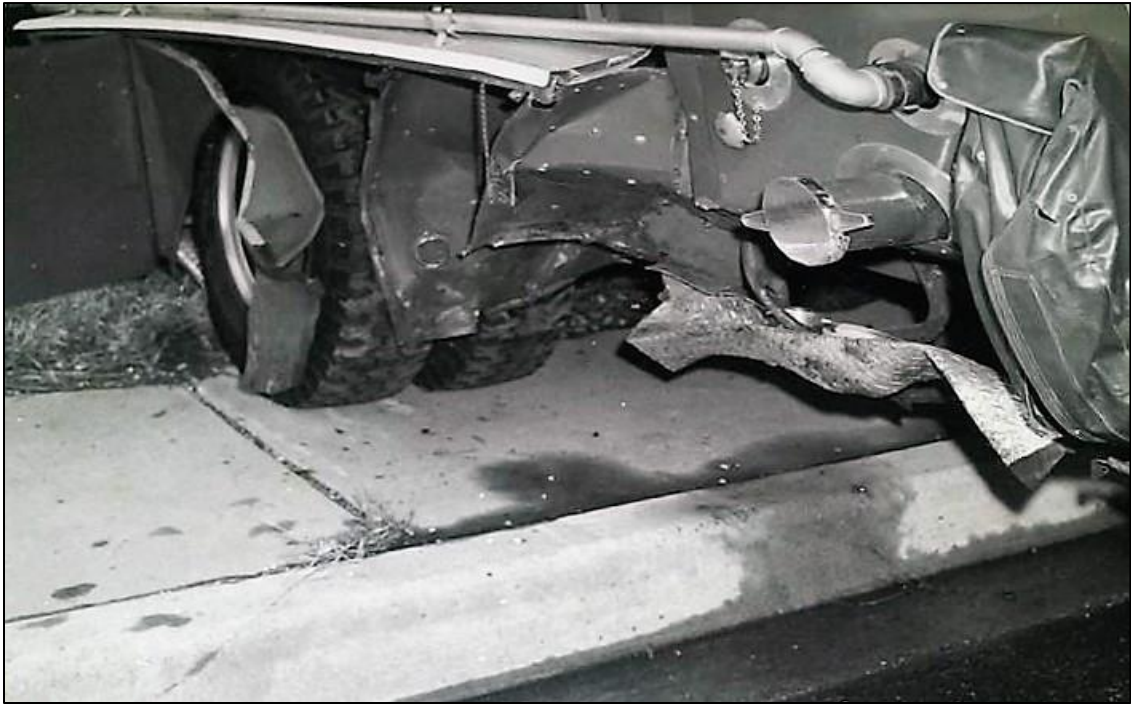
Right side of fire truck at pump panel.

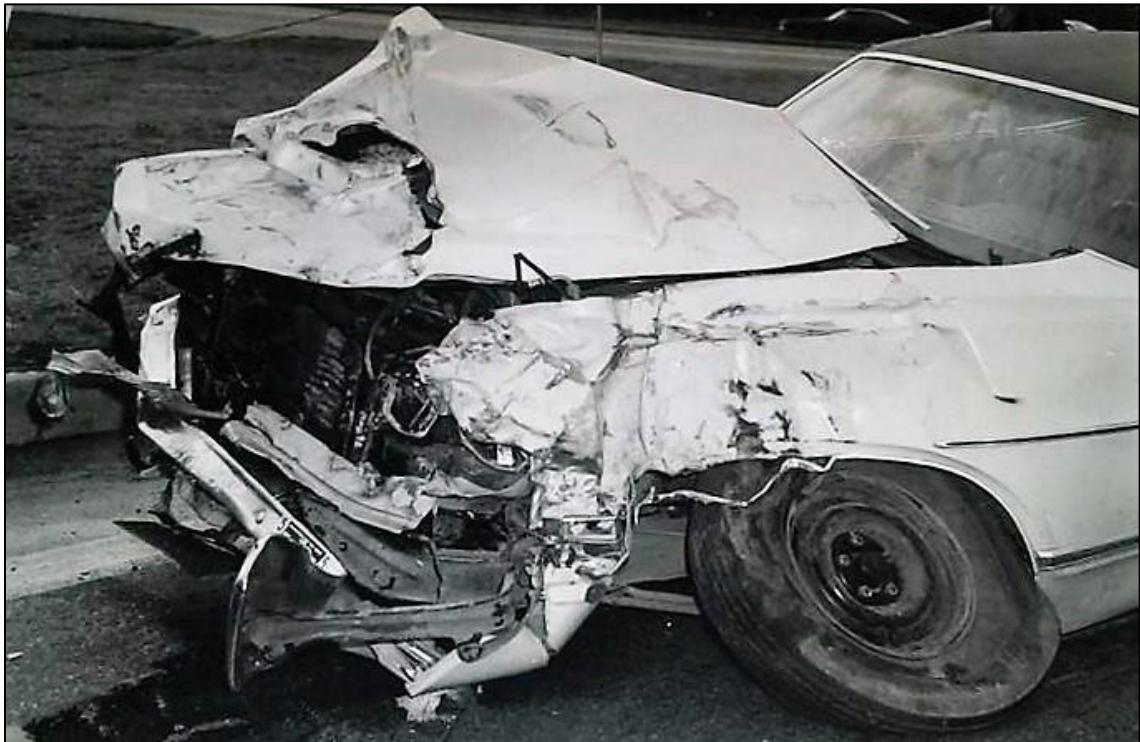
Automobile that struck the Fort Meade pumper.
